Mining Warden
Yallourn Mine Batter Failure Inquiry

Mining Warden - Yallourn Mine Batter Failure Inquiry

EXECUTIVE SUMMARY

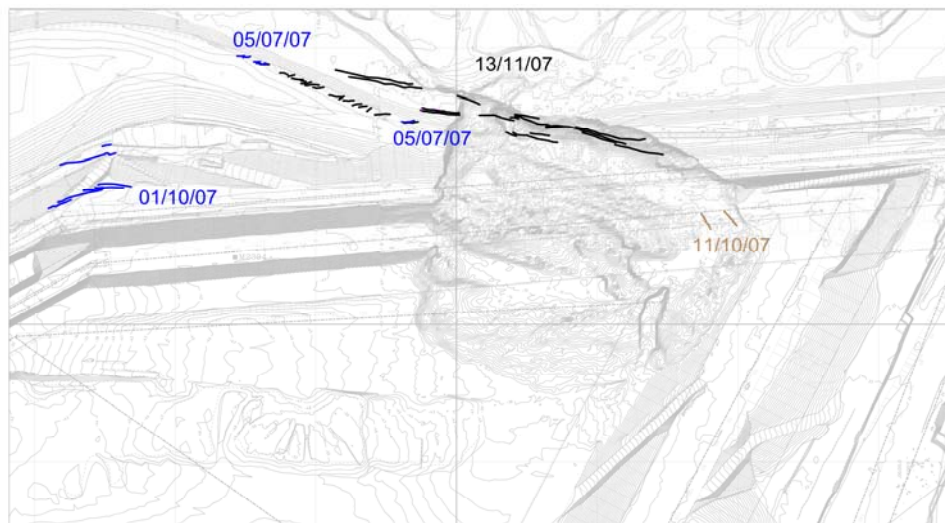
Figure 6: Cracks mapped prior to failure; colour coded with dates shown

Figures 6 and 7 show the location and date that cracks were located prior to and after the failure. Cracks were mapped for distance of up to 300 to 400m to the north of the NE Batter crest and were still being located up to one and a half months after the failure. The areal extent of the cracks together with the monitoring shows that the whole NE Batter was moving and could potentially have been included in a collapse. The groundwater monitoring data also shows that the mass involved in this movement was also deep seated and located in the interseam clays well below the coal. The actual NE Batter failure was only a small portion of the mass that was moving.

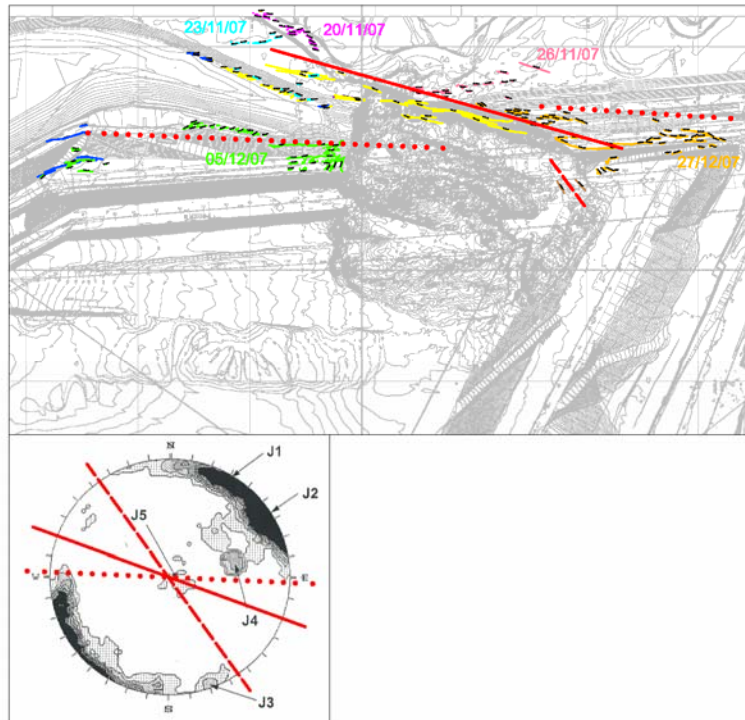
Figure 8: Comparison between cracks and joint data (1997)

Figure 8 is a comparison of the 1997 joint data with the cracks mapped before the failure. This shows the cracks were formed parallel to the main joint sets.

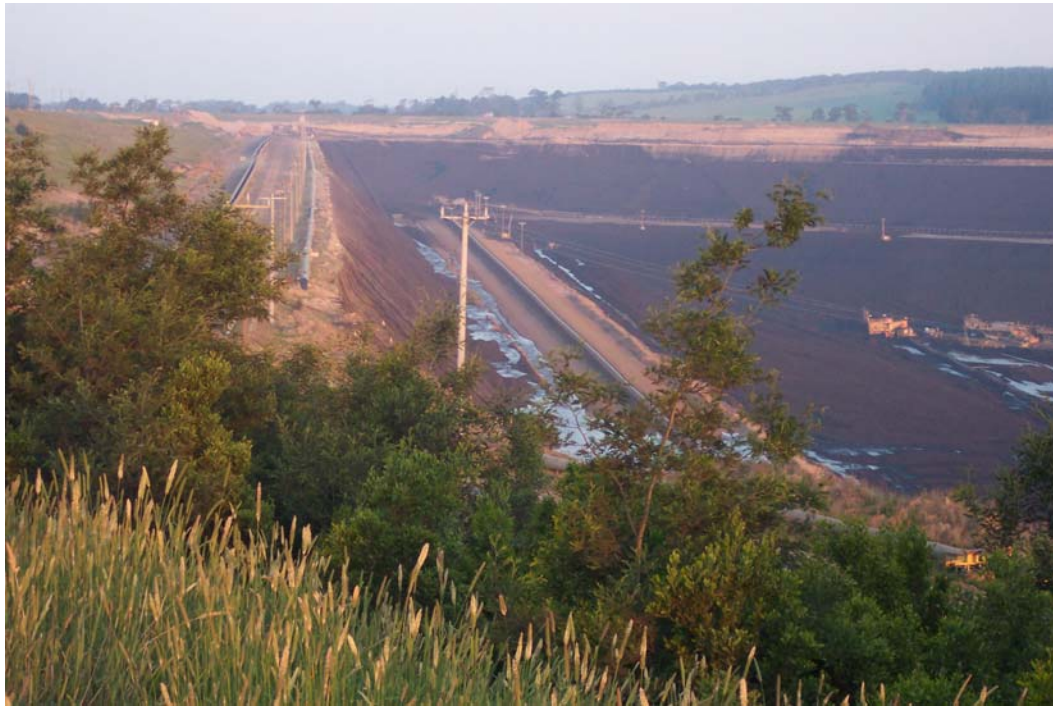
1. The Latrobe River is the predominant source of the water flows.
2. The slope is only marginally stable and failure is likely.
3. This failure could occur at any time.

Figure 9: General view along, NE Batter, note the bends in the pipeline and the line of power poles

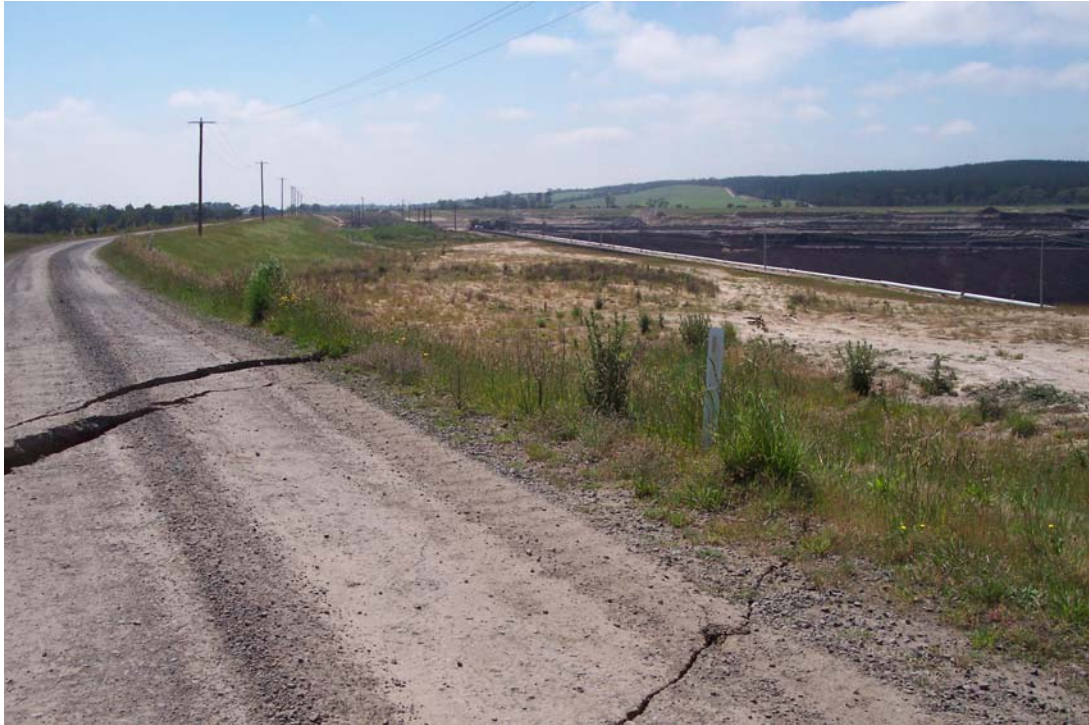
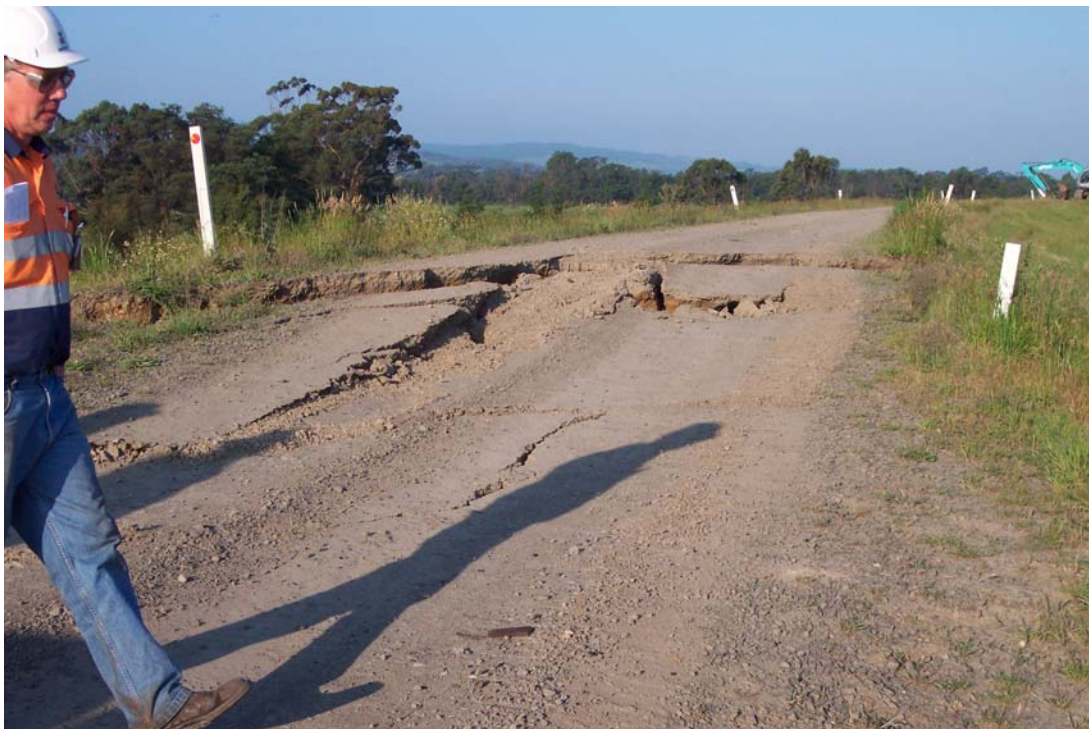
Figure 10: Cracks and subsidence across the Latrobe River Levee

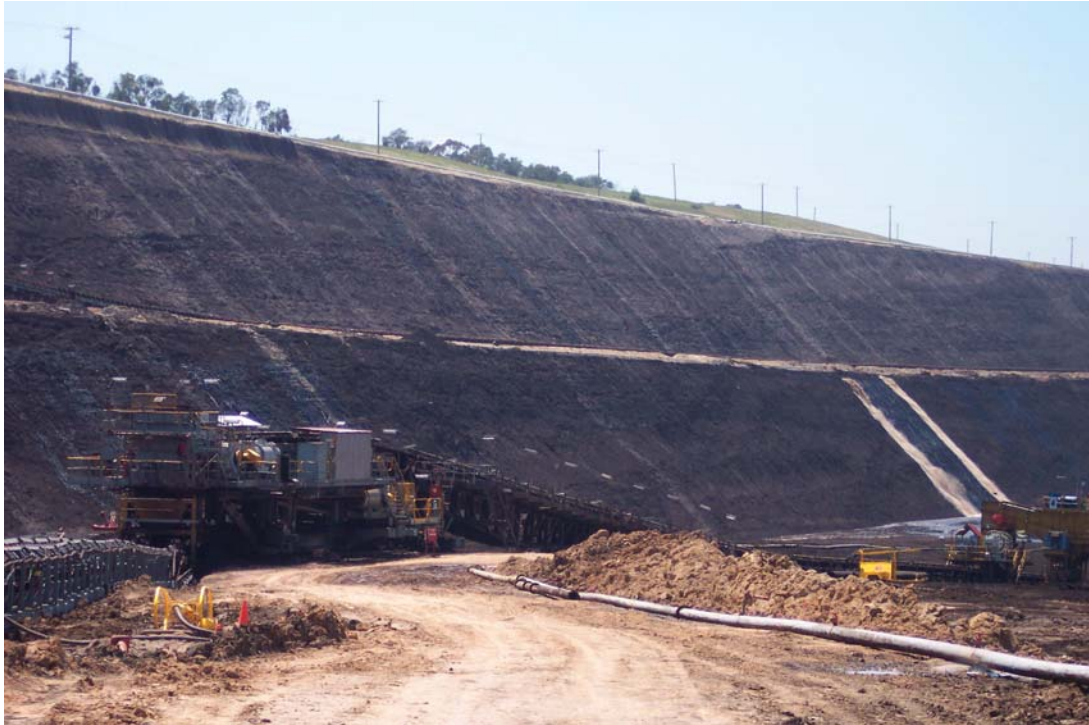
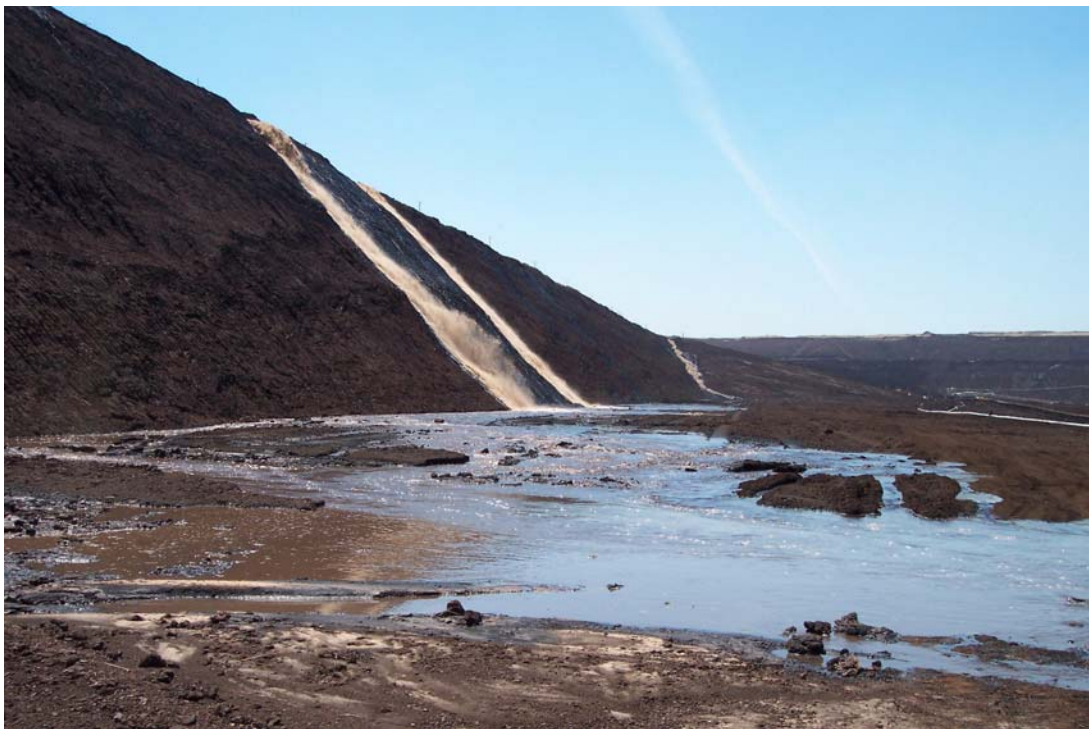
Figure 11: Water flow from mid coal bench

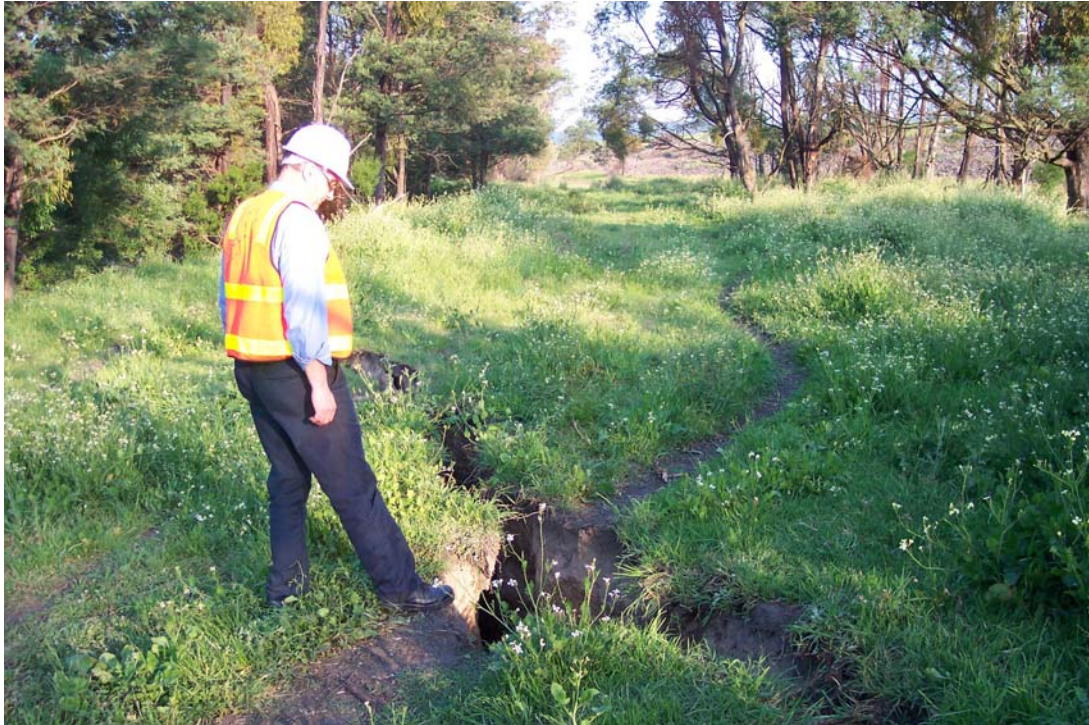
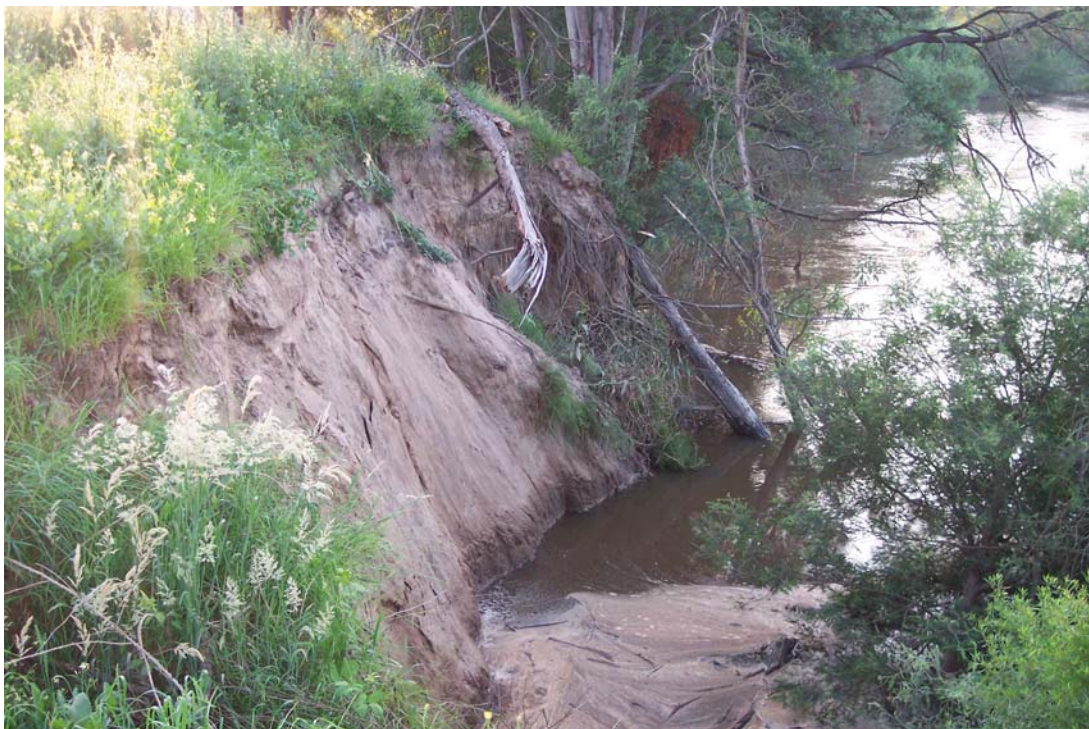
Figure 12: Crack in Latrobe River Floodplain and Latrobe River

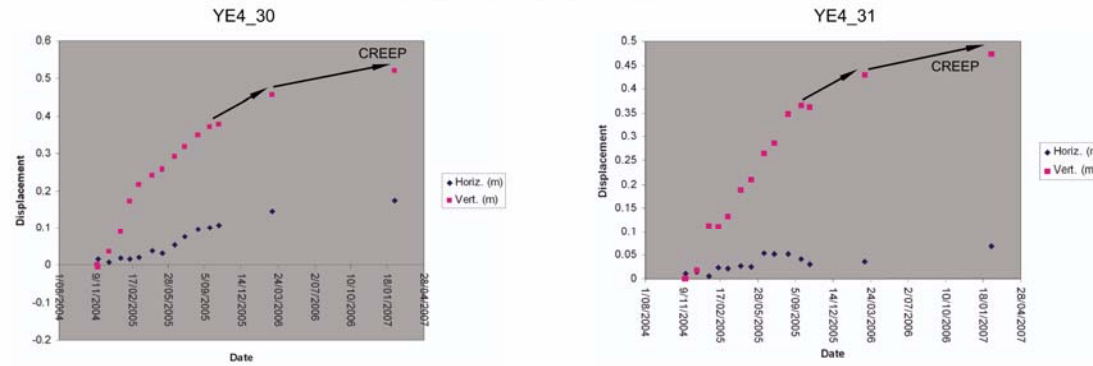
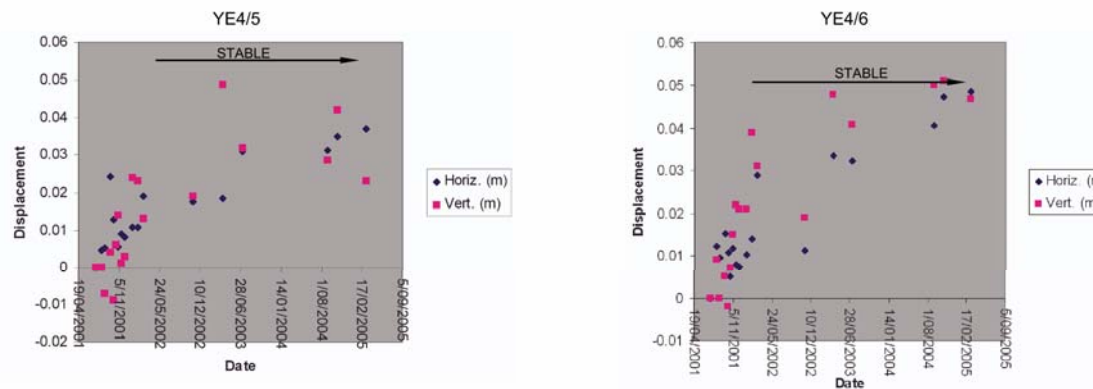
Figure 14: Mine floor movement pins

This shows the eastern end of the YEF has been subject to long term upward creep of the floor probably due to groundwater pressures.

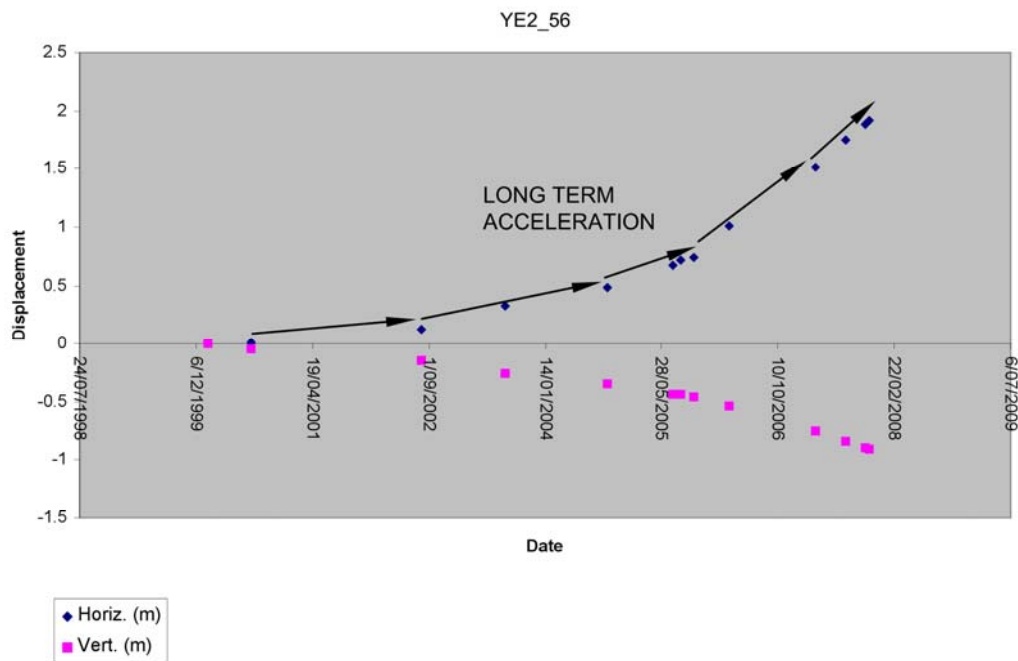
Figure 15: Long term movement for Batter pin YE2_56

Extensive experience has shown that long term accelerating movement patterns like that for the NE Batter, Figures 15 and 16, means that failure was always likely to occur, unless the movements could be stabilised by remedial measures.

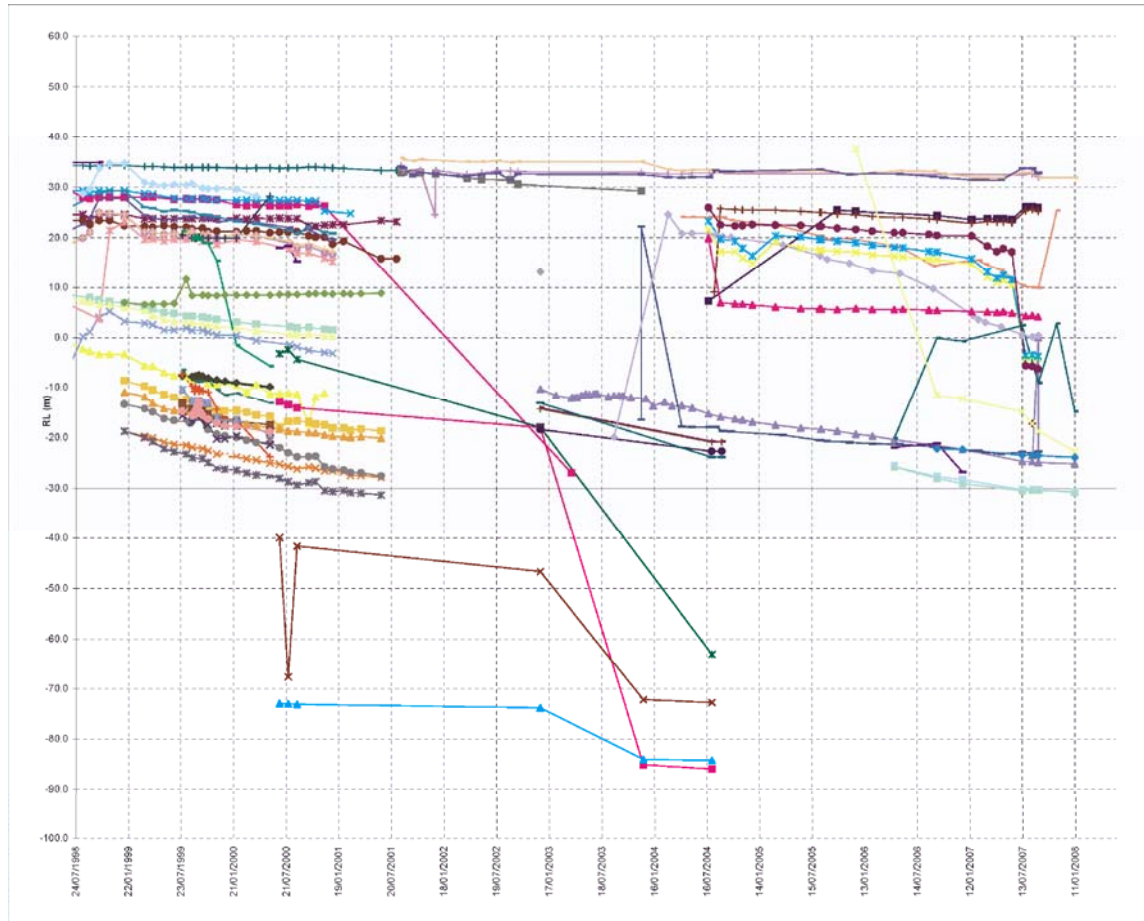
Figure 18: Hydrograph for NE Batter area piezometers

Ignoring what appear to be errors, this data shows:

1. A long term decreasing trend for most piezometers, 1998 till 2008.
2. A relatively steady pattern up till about early to mid 2006.
3. Disruptions to this steady pattern at the following approximate times:
 - (a) Mid 2006,
 - (b) January 2007,
 - (c) June 2007 and
 - (d) September 2007.
4. The disruptions include both rises and falls in levels or pressures.
5. These rises and falls are occurring through the profile and extend at depth into the interseam clays 10's of metres below the base of the coal seam.
6. A 15m rise in piezometer 25846 S01 between 7th September and 10th November 2007. This piezometer is located near the northern part of the failure.

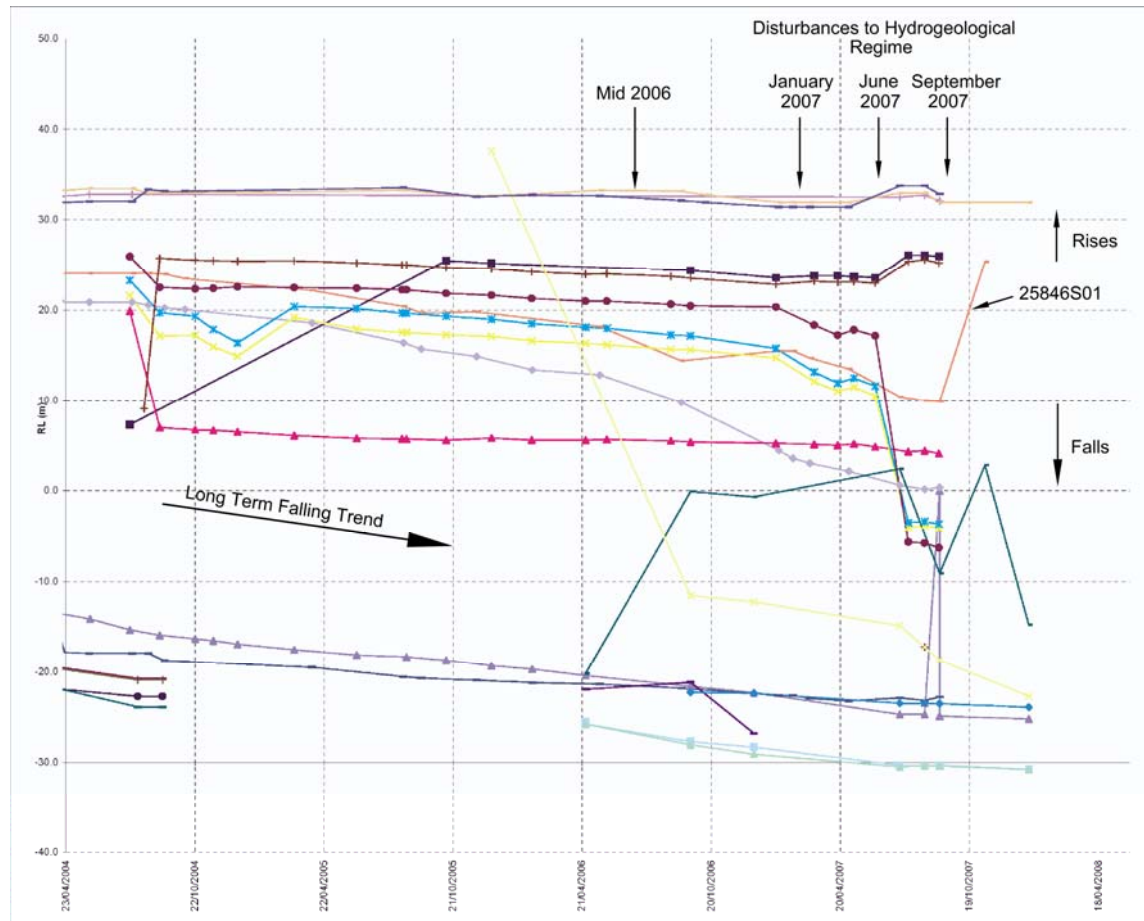
Figure 19: NE Batter piezometers 2004 to 2008

These changes in patterns are interpreted to be the result of disturbances to the existing hydrogeological regime due to the large scale and deep seated ongoing movement of the NE Batter. This eventually led to hydraulic connection between the Latrobe River and the joints in the coal. The rise in 25846 S01 which is located at the rear of the failure was 15 to 16m. This rise is clearly a result of almost direct hydraulic connection between the Latrobe River and the joints/cracks that eventually formed the rear release plane of the failure.

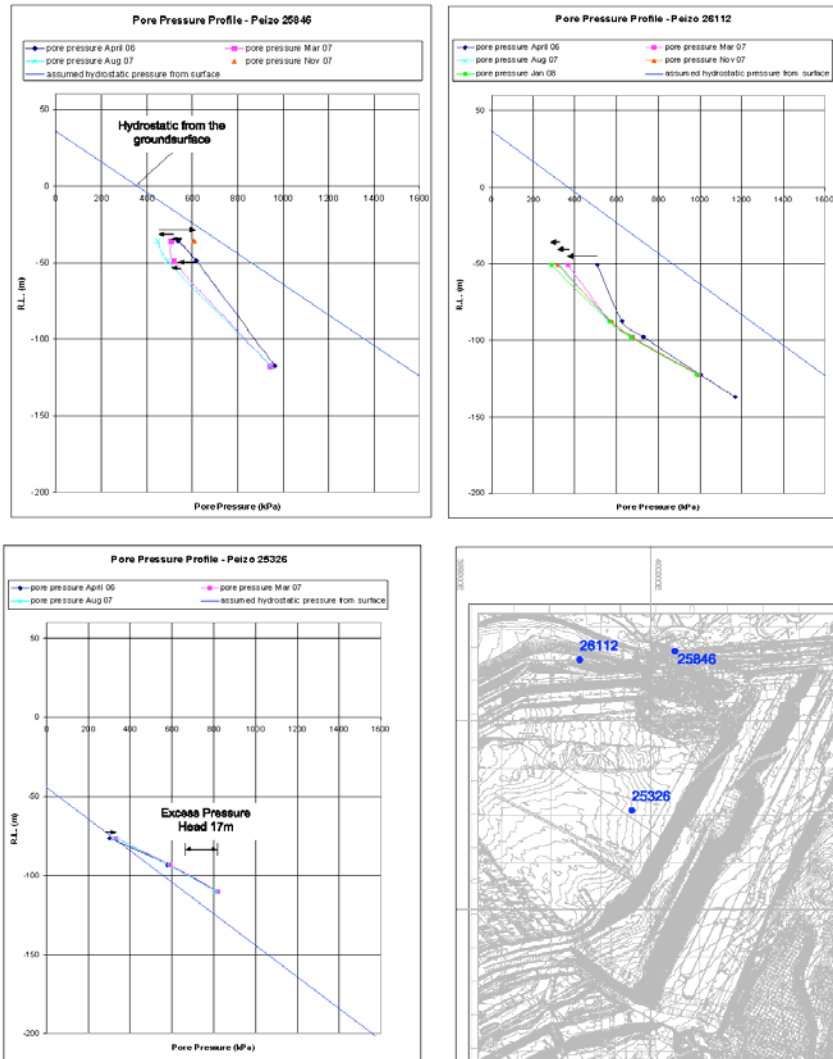
Figure 20: Piezometric pressures with depth showing changes over time

I consider that high pore pressures in the interseam clays below the mine floor and the NE Batter have contributed to large scale and deep seated long term movement of the NE Batter.

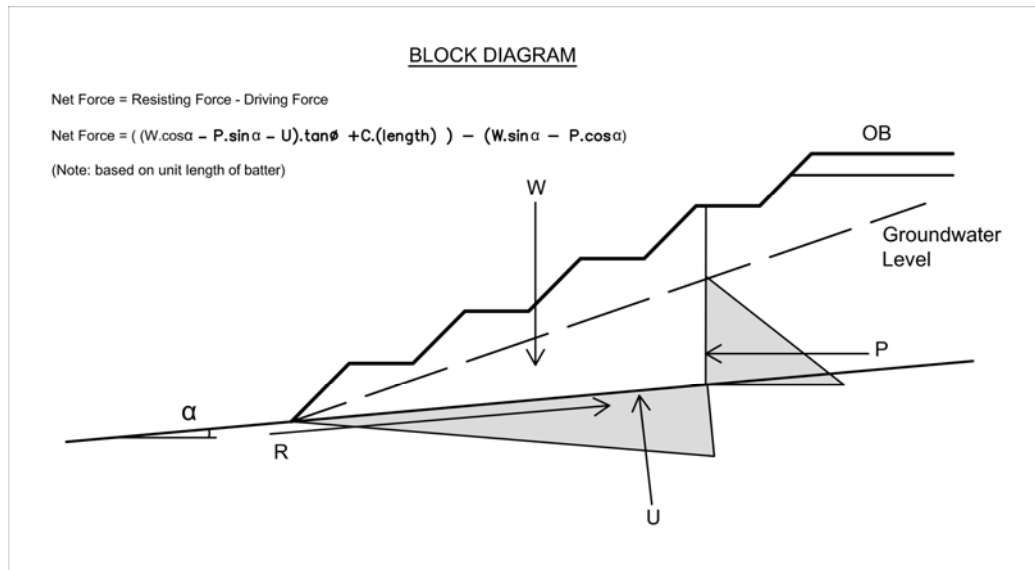
Figure 21: Groundwater model for block sliding Batter stability 2001 (Reference 60)

predicated on a groundwater model that had both coal seam and interseam pressures falling to zero at the toe of the batter, Figure 21. I note there are a number of recommendations and warnings including about interseam pressures and installing horizontal bores.

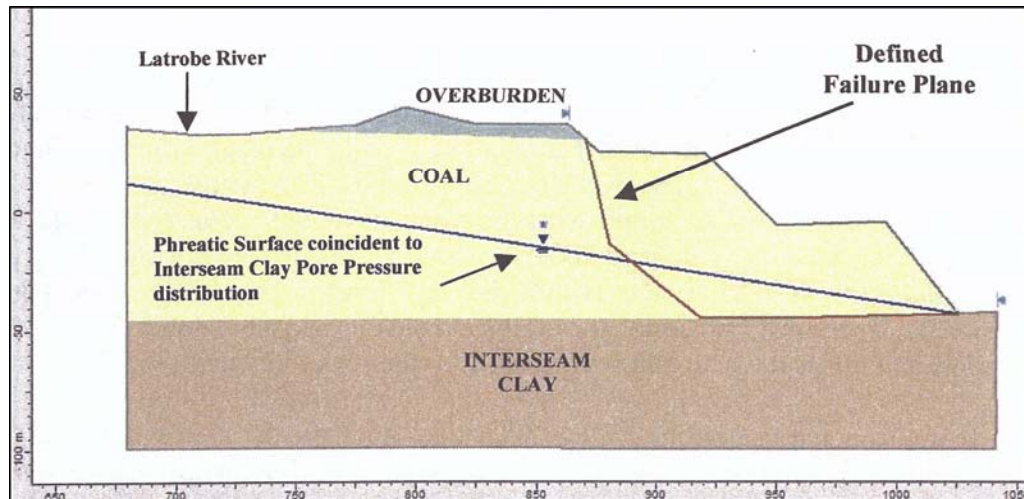
**Figure 22: Failure mechanism for NE Batter
(After Reference 56)**

The analysis focussed on a different failure mechanism, Figure 22, compared to the traditional block sliding model in Figure 21. This mechanism is closer to a circular failure. The analyses also assumed the coal groundwater level and the interseam clay pore pressure distributions were zero at the toe of the batter.

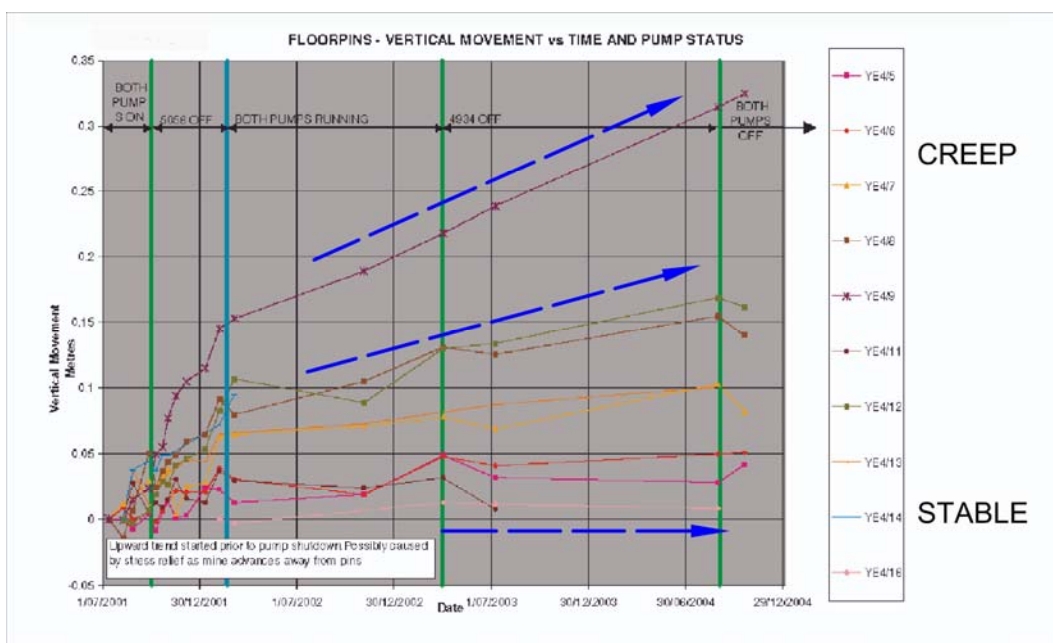
**Figure 23: Floor pin movement data, October 2004
(Reference 75)**

Figure 23 shows the floor movement data and illustrates a number of pins, which are the pins located towards the northeast in the YEF, show a long term upward trend, creep. Although the explanation by the Mine Geologist could be correct it could also be the result of an alternative effect, that is excess pore pressures in the interseam clays.

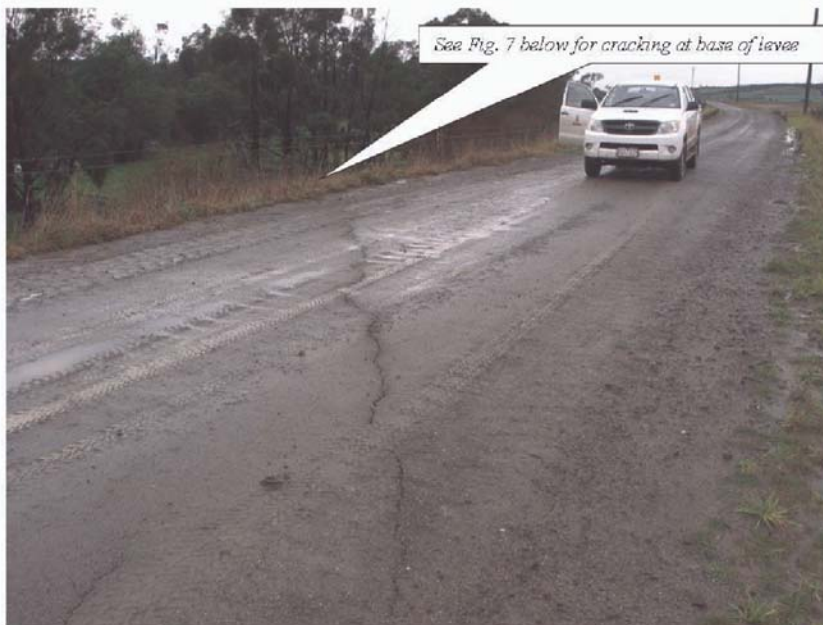
Figure 7 Cracking at base of levee Latrobe River Flood Plain

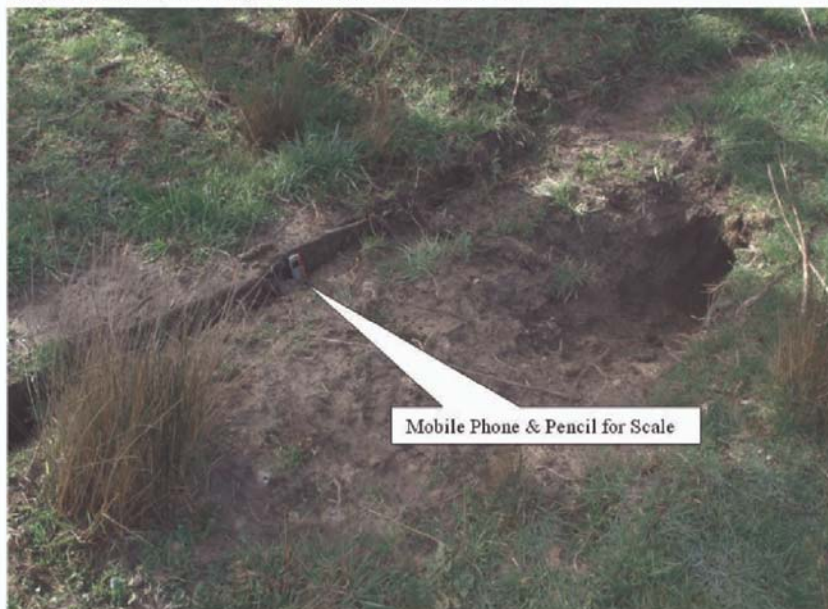
Figure 24: Cracking and subsidence on NE Batter in July 2007
